# Mobile Intel® Celeron® Processor on .13 Micron Process in Micro-FCPGA Package

Specification Update

*May 2005*

Document Number: 251309-026

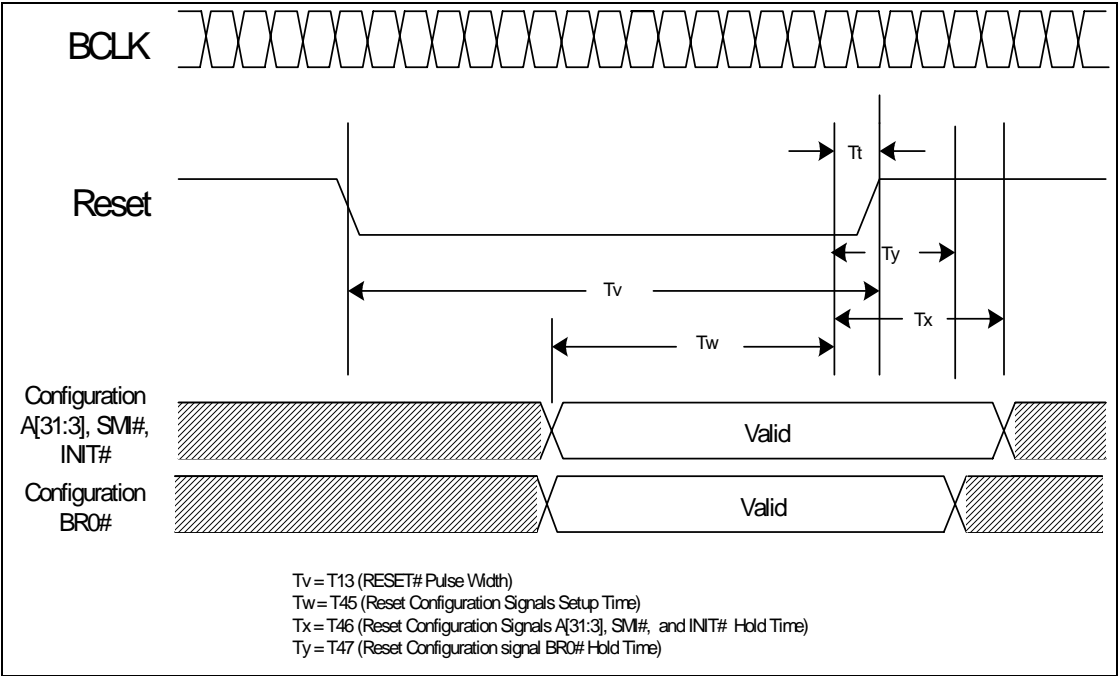
Figure 12. System Bus Reset and Configuration Timings

The BR0# maximum hold time has changed to 2 BCLKs. This change will be shown in the “System Bus AC Specifications (Reset Conditions)” table and “System Bus Reset and Configuration Timings” figure of the *Mobile Intel® Celeron® Processor on .13 Micron Process in Micro-FCPGA Package Datasheet*. This change will be incorporated in the next revision of the datasheet.
